Glacier Lake 513, Peru: Lessons for early warning service development

Development and implementation of a GLOF Early Warning System

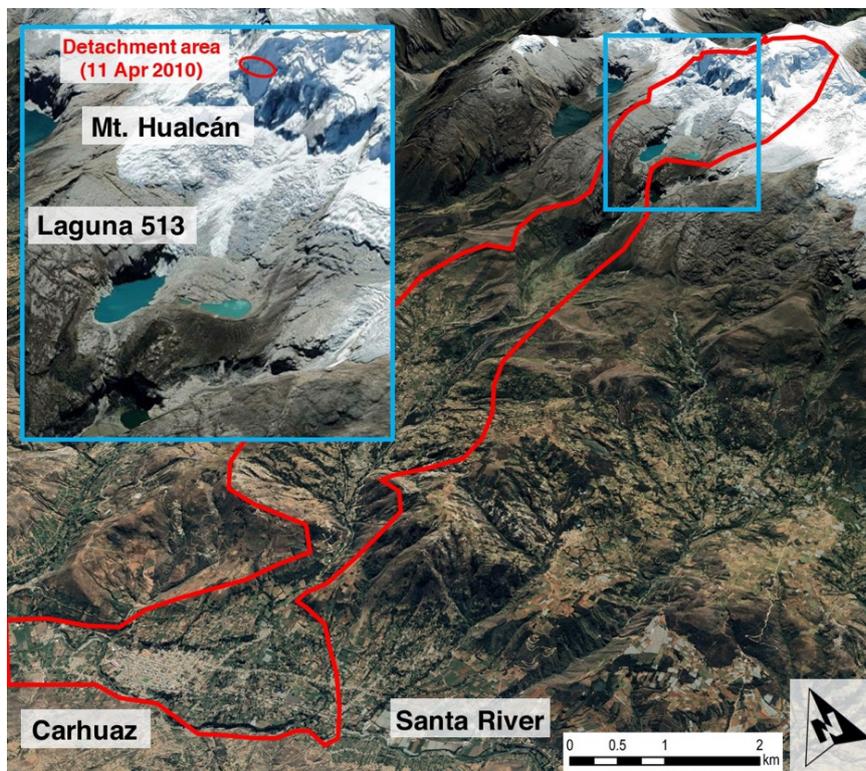
Overview map of Lake 513 and Carhuaz, indicating the 2010 ice avalanche source zone producing the GLOF that reached down to Carhuaz.

However, Laguna 513 was heavily impacted when a 450 000 cubic metres (m³) rock-ice avalanche detached from the southwest slope of Mt. Hualcán (Carey et al., 2012) (Fig. 2) on 11 April 2010, at about 8 a.m. local time. The avalanche caused a tsunami-like push-wave on the lake, resulting in a dam spillover despite the over 20 m freeboard. Traces of the wave indicate an overtopping of the dam by about 5 m – corresponding to a wave height of about 24 to 25 m – with a peak discharge of rate of several tens of thousands m³ per second (Schneider et al., 2014). The resulting GLOF damaged several bridges, water service infrastructure along its trajectory and eventually reached the debris fan of the city of Carhuaz (about 20 000 inhabitants), where the coarse material of the GLOF was deposited. A total of 0.7 km² of agricultural land was buried and the Santa Valley highway was affected, but no lives were lost.

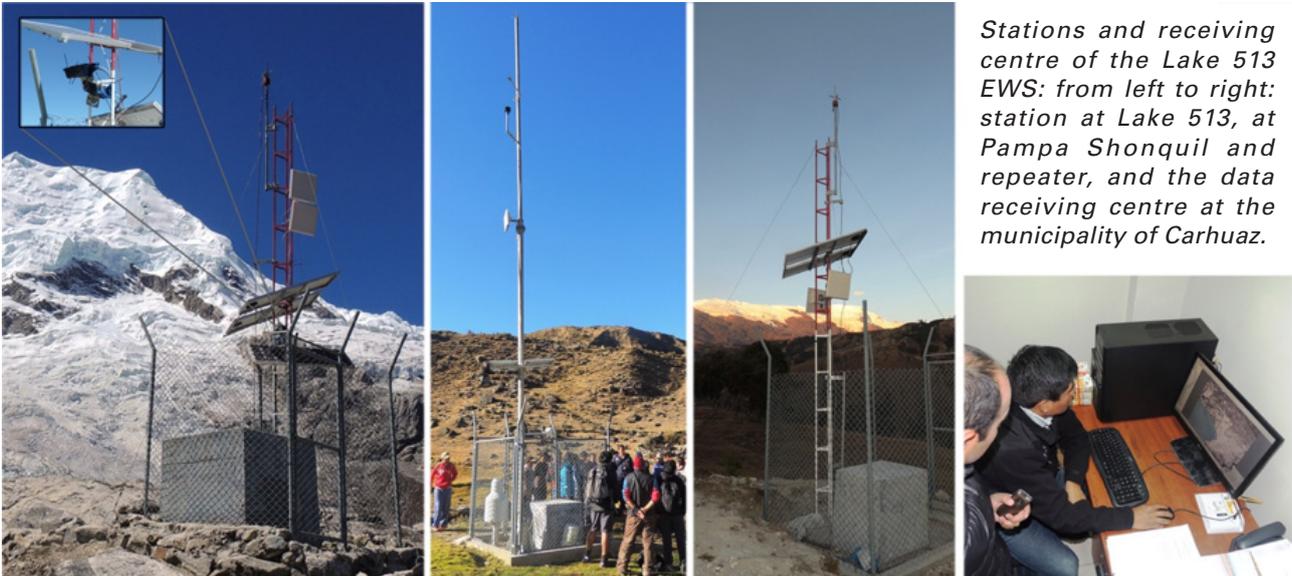
Stations and receiving centre of the Lake 513 EWS: from left to right: station at Lake 513, at Pampa Shonquil and repeater, and the data receiving centre at the municipality of Carhuaz.

With the knowledge and information gathered, the local and international team worked together, each contributing their expertise, to design an EWS that would overcome the challenges of Laguna 513. The design comprised two stations – a main station at the Laguna 513 dam and a station in the Pampa Shonquil,

which would include meteorological measuring instruments – a data centre in the municipality of Carhuaz, a warning station in the community of Pariacaca, and a repeater station for transferring the signal from the lake to the data centre (Fig. 3).

1. Data centre Carhuaz (2 640 m a.s.l.): receiving antenna, screen with real-time data access, server for data storage, infrastructure for launching alarms.
2. Repeater station (3 189 m a.s.l.): receiving and sending antenna.
3. Station Laguna 513 (4 491 m a.s.l.): 2 cameras taking photos every 5 seconds during daylight times, one looking at the face of Mt. Hualcán, one observing the dam. 4 geophones located close to the station, continuously measuring and sending data in 5 second intervals, in order to detect potential mass movements (e.g. ice avalanche) impacting the lake. Receiving and sending antenna and data logger.
4. Station Pampa Shonquil (3 600 m a.s.l.): river discharge station (using pressure sensor), meteorological station with sensors for measuring

air temperature and humidity, precipitation, wind speed, and solar radiation. Sending antenna and data logger.

5. Information receiving and warning station at Pariacaca (3 138 m a.s.l.): the monitoring system informs locals about events at Laguna 513 and sirens activated from the Data Centre Carhuaz to facilitate evacuation.

All stations were equipped with solar panels and batteries for energy generation and storage, however energy availability remained a limiting factor, in particular at the glacier lake station as the peaks of the Cordillera Blanca experience a high frequency of cloud coverage. Each station had a mast where most of the instruments were fixed, a concrete lockable box for the electronic equipment, and a protective fence. Emergency power aggregates were available in the municipal building to prevent data losses and interrupted access during blackouts.
